AD NUMBER	
AD357977	
CLASSIFICATION CHANGES	
TO:	UNCLASSIFIED
FROM:	SECRET
LIMITATION CHANGES	
TO: Approved for public release; distribution is unlimited. Document partially illegible.	
FROM: Distribution authorized to U.S. Gov't. agencies only; Administrative/Operational Use; 1953. Other requests shall be referred to Atomic Energy Commission, Washington, DC. Document partially illegible.	
AUTHORITY	
AEC ltr 16 Jun 1980 ; AEC ltr 16 Jun 1980

The purpose of Signal Corps participation in Project 3.20 was to determine the amounts of thermal flux (cal) and peak overpressure (psi) required to cause severe, moderate, light, and negligible damage to selected signal communications-electronics items of equipment and material for which inadequate or no data existed. Knowing these factors it is believed that responsible signal officers can better plan their tactical communications systems and take passive protective measures to reduce damage and losses to acceptable minimums. These data will also be used to improve design of equipment and material.

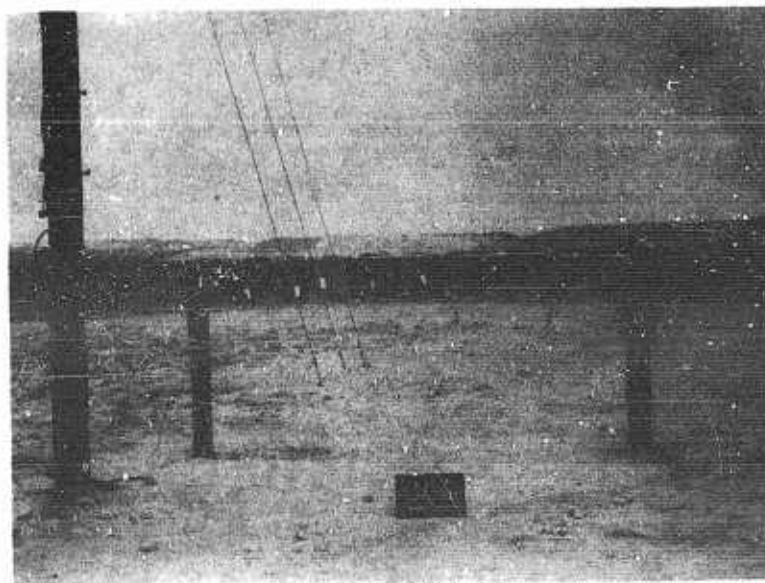
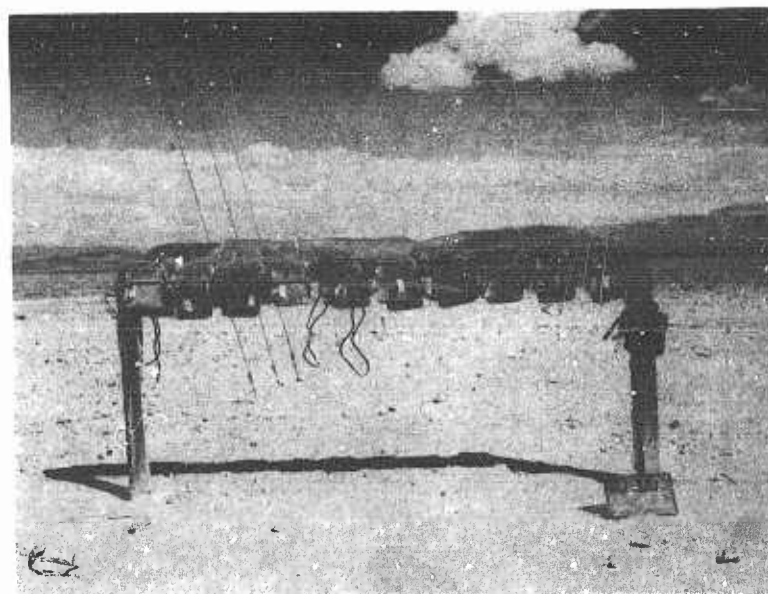
Fig. 3.2 Shot 9, Test Group 1, 1-1/2 Mile Pole Line, Pole D-1 and EE-8 Field Telephones used to Test Circuits.
(Top-before, Bottom-after) 9080 ft, 8 cal, 3 psi

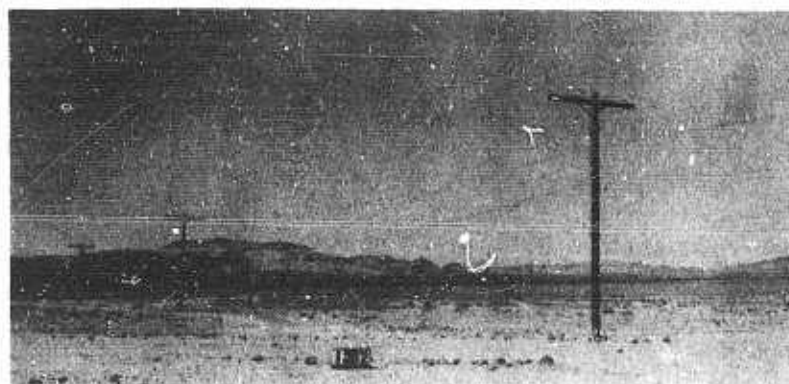
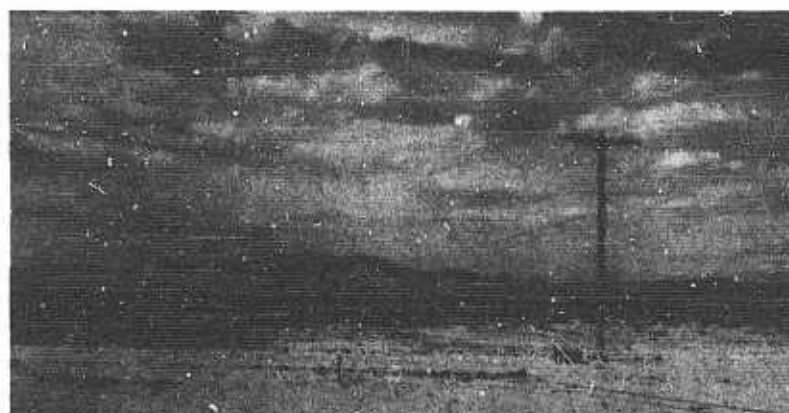
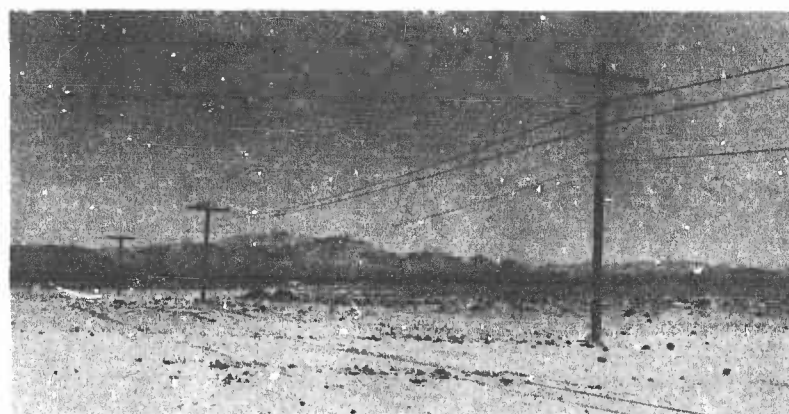
Fig. 3.3 Shots 9 and 10, Test Groups 1 and 1A, Radial Pole Line, Poles D-1 through D-4. D-4 in Foreground.
 (Top-before 9, Center-after 9, Bottom-after 10)
 Shot 9 - 9080-8450 ft, 8-10 cal, 3-3.1 psi.
 Shot 10 - 8350-7850 ft, 5.5-6.5 cal, 1-1 psi

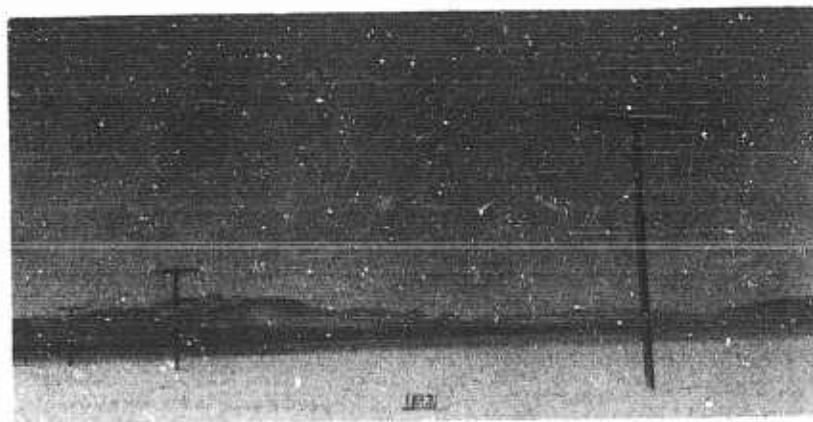
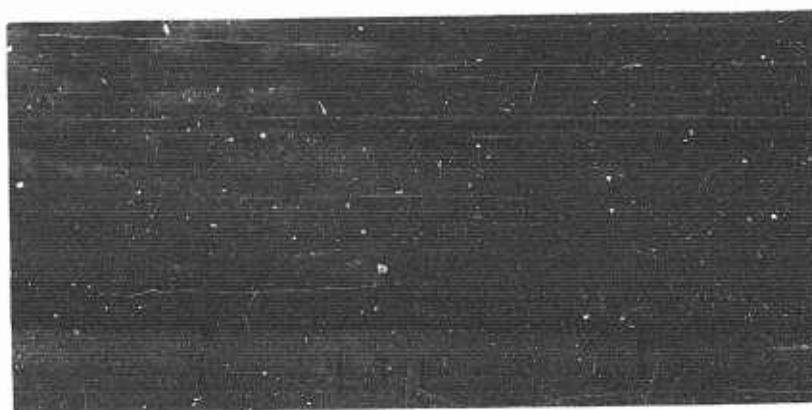
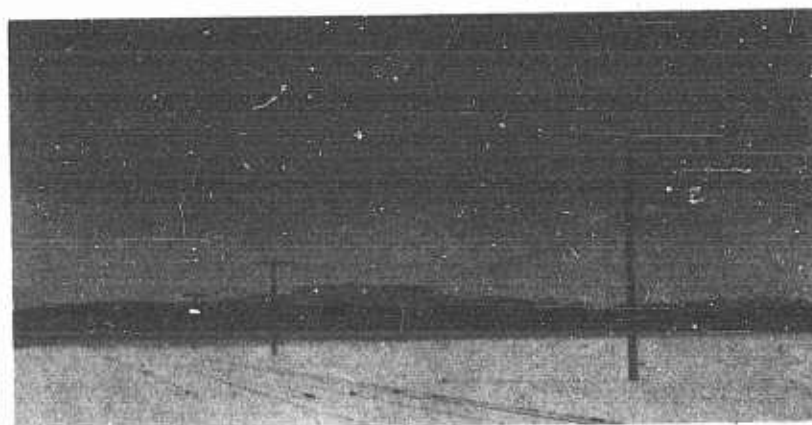
Fig. 3.4 Shots 9 and 10, Test Groups 1 and 1A, Radial Pole Line, Poles D-3 through D-7. D-7 in Foreground.
 (Top-before 9, Center-after 9, Bottom-after 10)
 Shot 9 - 8750-8050 ft, 9.5-11.5 cal, 3-3.4 psi.
 Shot 10 - 8000-7425 ft, 6-7.5 cal, 1-1 psi.

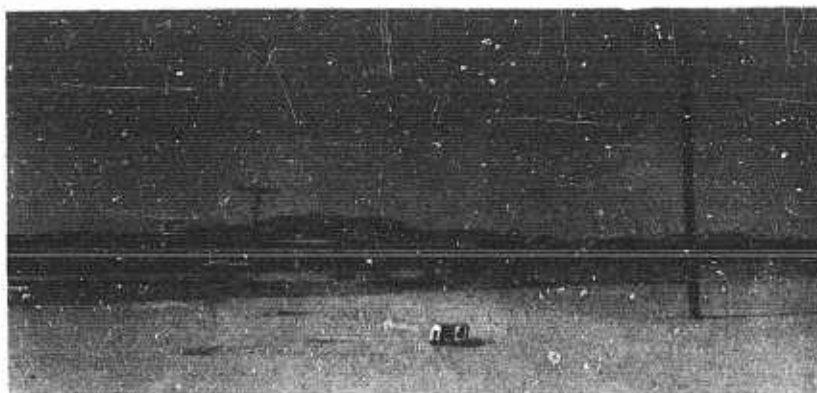
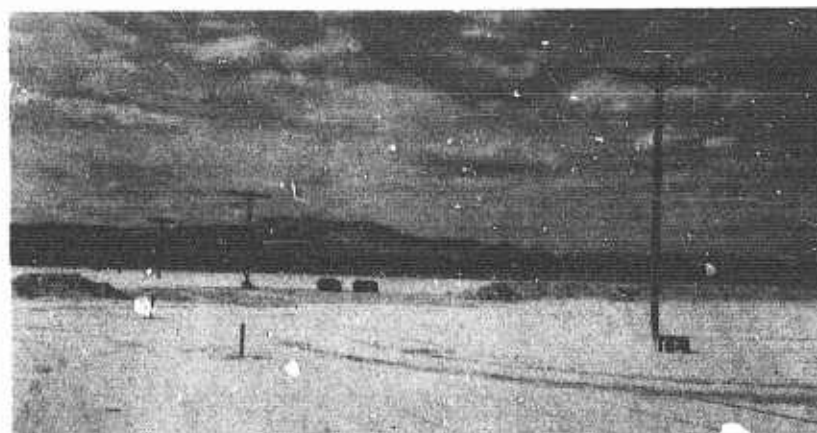
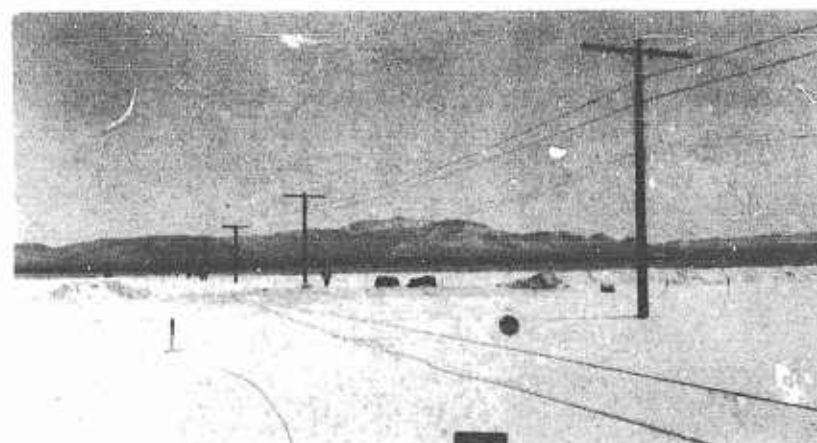
Fig. 3.5 Shots 9 and 10, Test Groups 1 and 1A, Radial Pole Line, Poles L-1 through D-10. D-10 in Foreground.
 (Top-before 9, Center-after 9, Bottom-after 10)
 Shot 9 - 9080-7550 ft, 8-13 cal, 3-3.6 psi.
 Shot 10 - 8350-6950 ft, 5.5-8.5 cal, 1-1 psi.

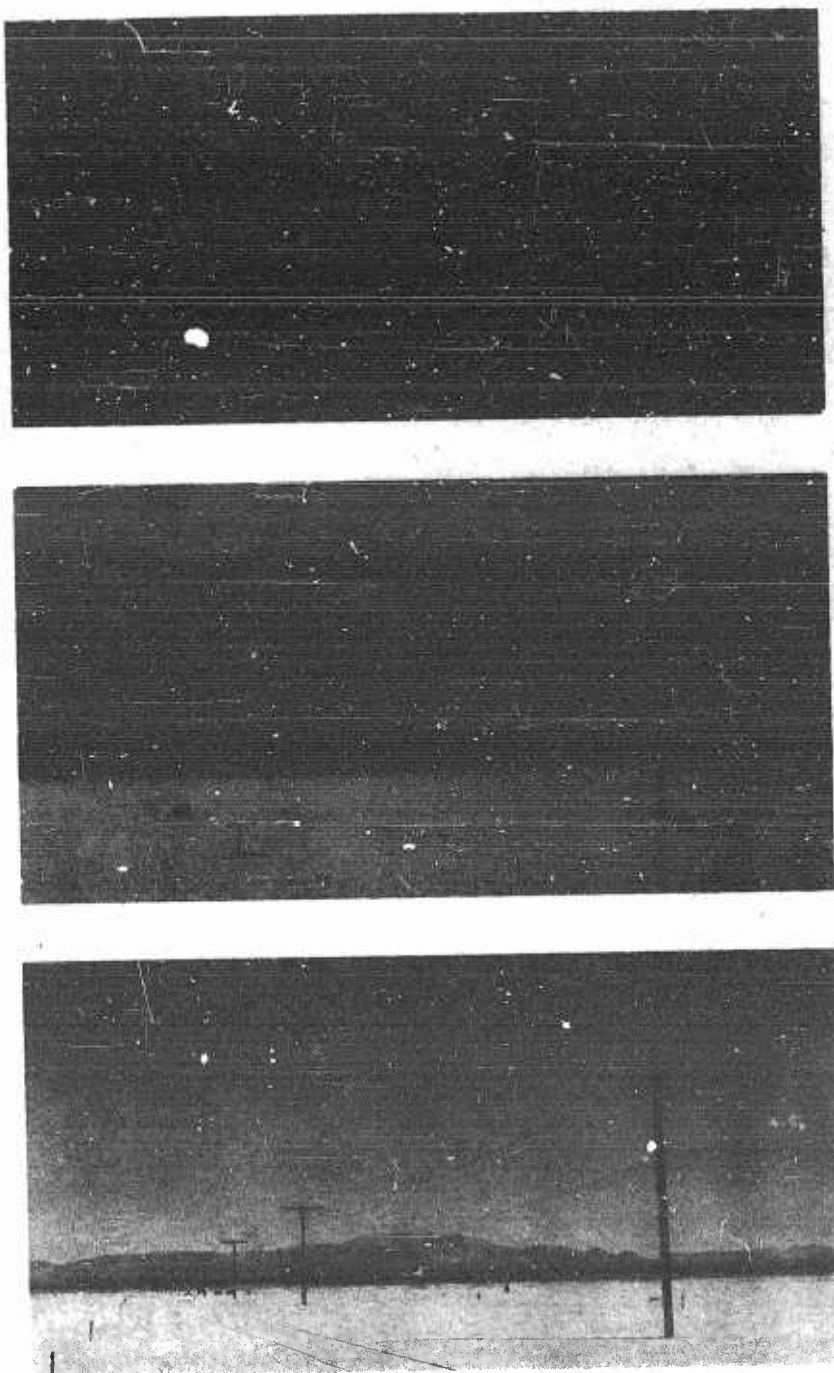
Fig. 3.6 Shots 9 and 10, Test Groups 1 and 1A, Radial Pole Line, Poles D-1 through D-13. D-13 in Foreground.
 (Top-before 9, Center-after 9, Bottom-after 10)
 Shot 9 - 9080 ft, 8-15 cal, 3-4.1 psi.
 Shot 10 - 8350-6480 ft, 5.5-10.5 cal, 1-2 psi.

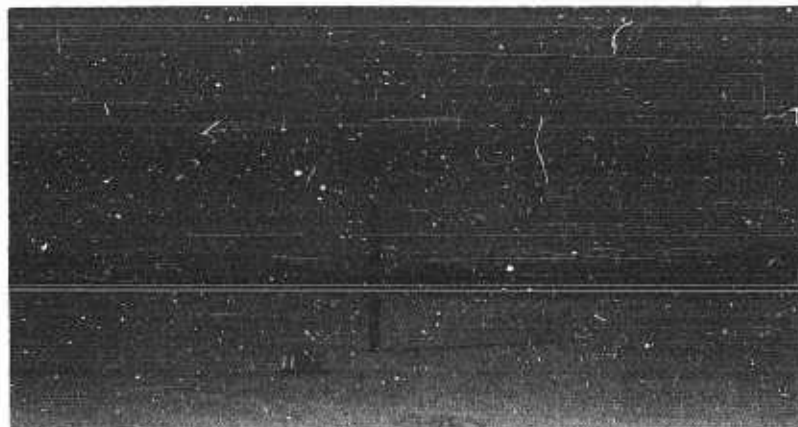
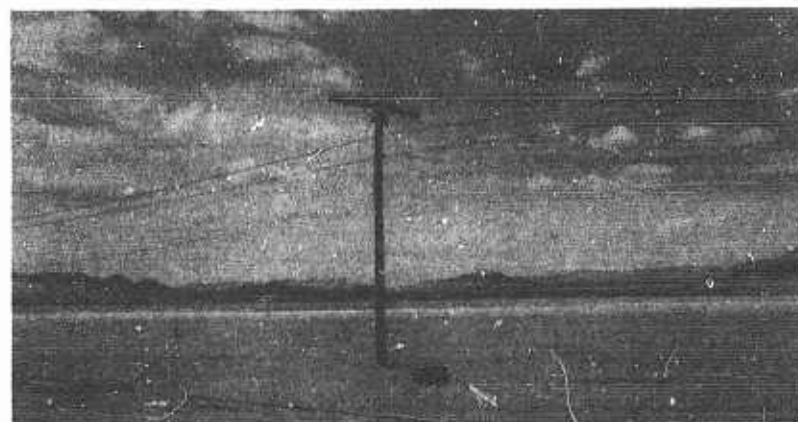
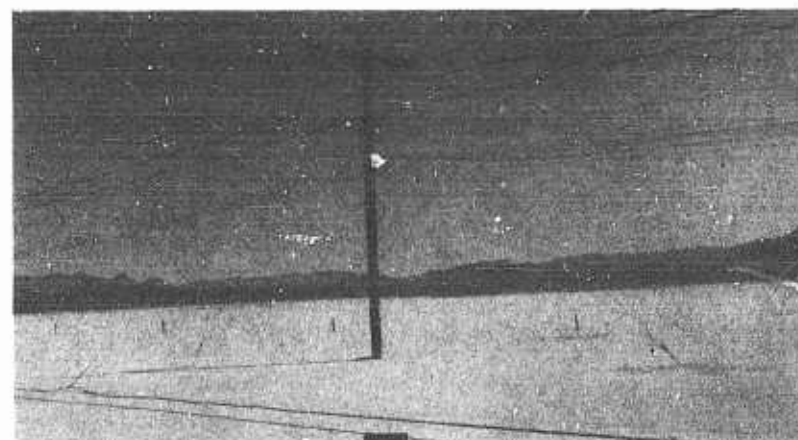
Fig. 3.7 Shots 9 and 10, Test Groups 1 and 1A, Radial Pole Line, Pole D-14. (Top-before 9, Center-after 9, Bottom-after 10)
Shot 9 - 6950 ft, 16 cal, 4.2 psi.
Shot 10 - 6350 ft, 10.5 cal, 2 psi.

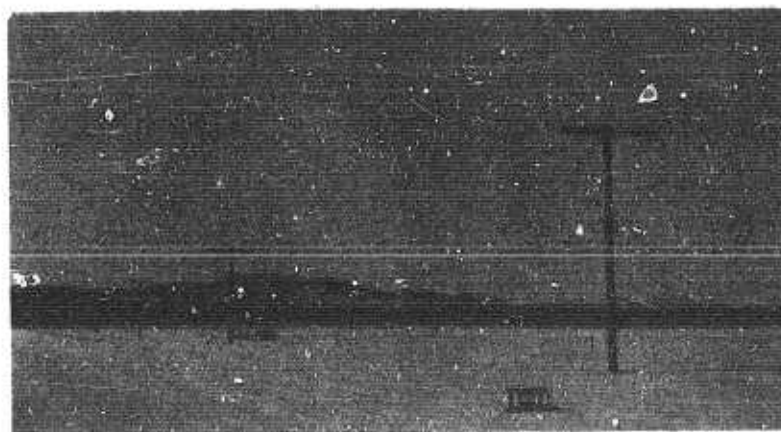
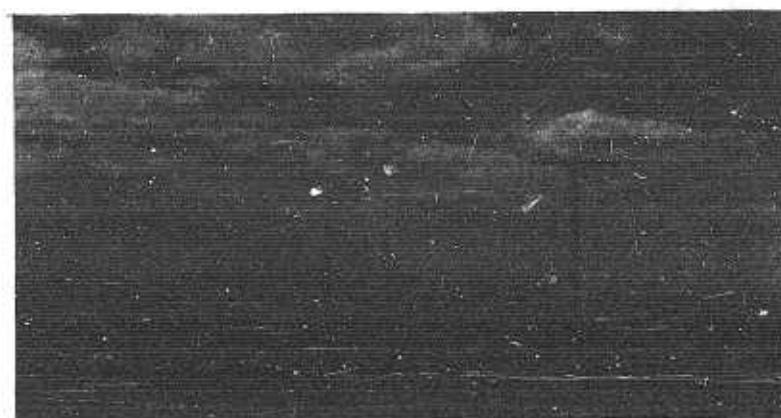
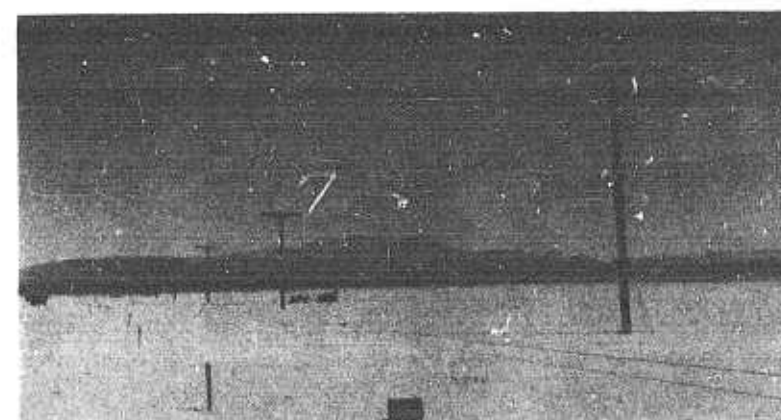
Fig. 3.8 Shots 9 and 10, Test Groups 1 and 1A, Radial Pole Line, Poles D-1 through D-17. D-17 in Foreground.
 (Top-before 9, Center-after 9, Bottom-after 10)
 Shot 9 - 9080-6500 ft, 8-18.5 cal, 3-4.6 psi.
 Shot 10 - 8350-5860 ft, 5.5-12.5 cal, 1-2 psi.

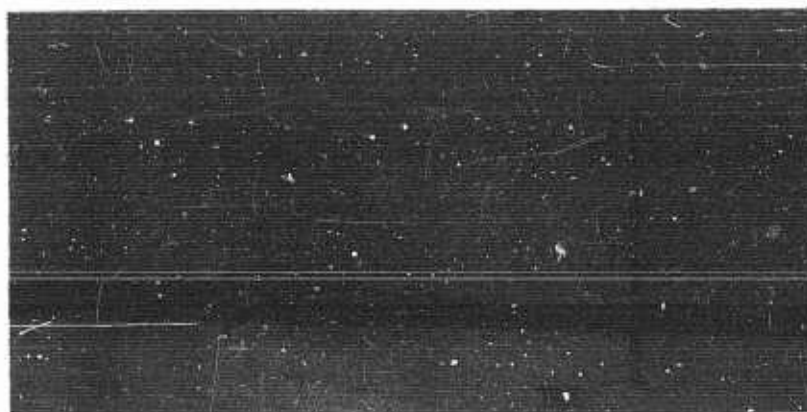
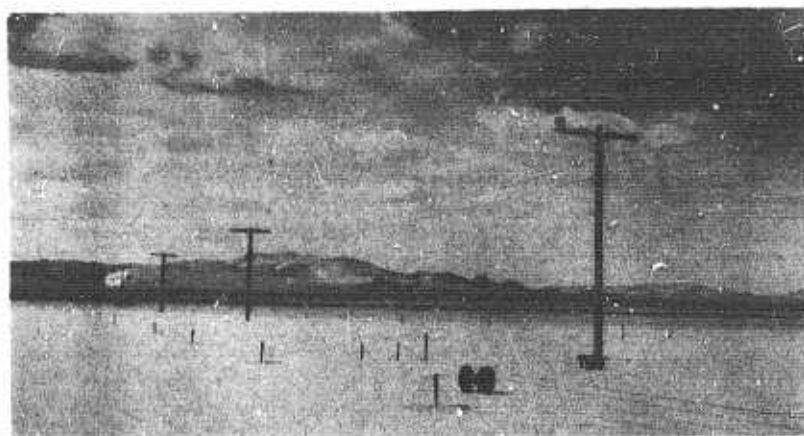
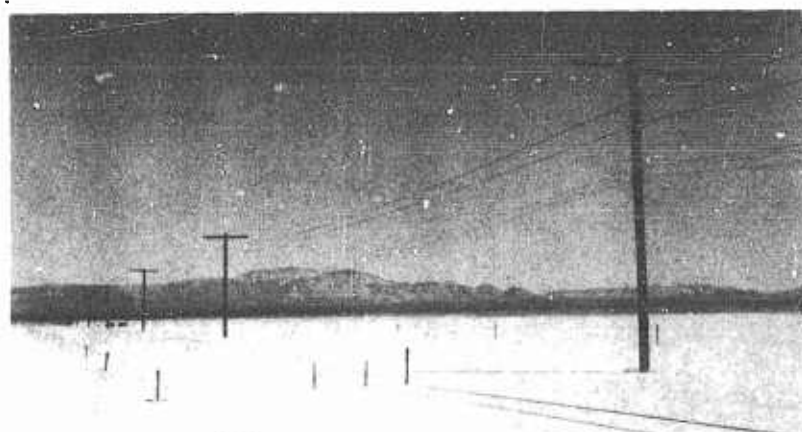
Fig. 3.9 Shots 9 and 10, Test Groups 1 and 1A, Radial Pole Line, Poles D-1 through D-20. D-20 in Foreground.
 (Top-before 9, Center-after 9, Bottom-after 10)
 Shot 9 - 9080-6050 ft, 8-22 cal, 3-5 psi.
 Shot 10 - 8350-5440 ft, 5.5-14.5 cal, 1-2 psi.

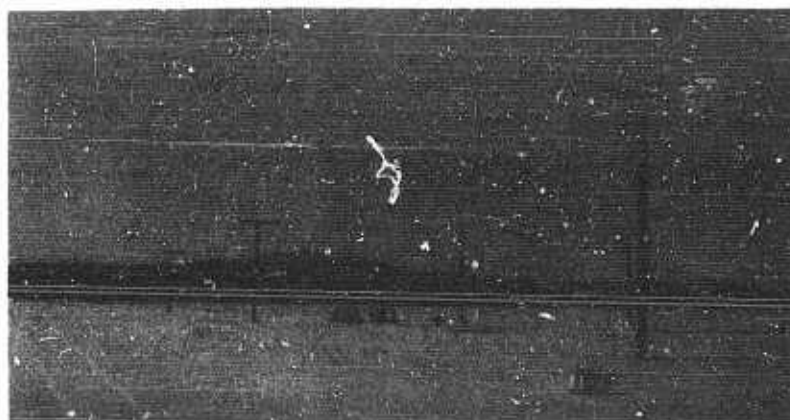
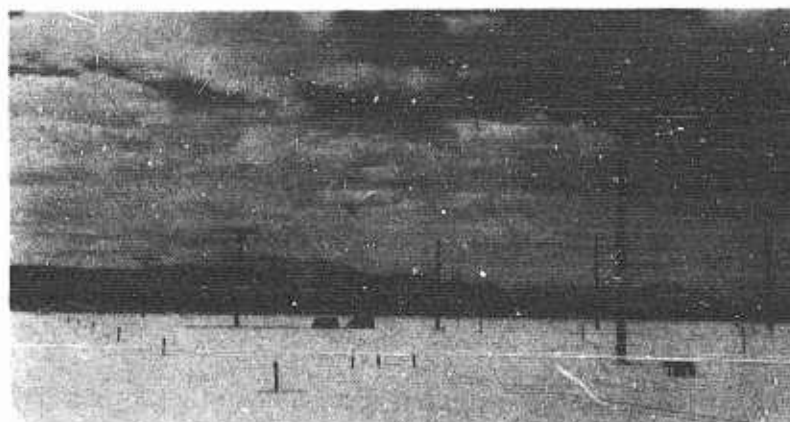
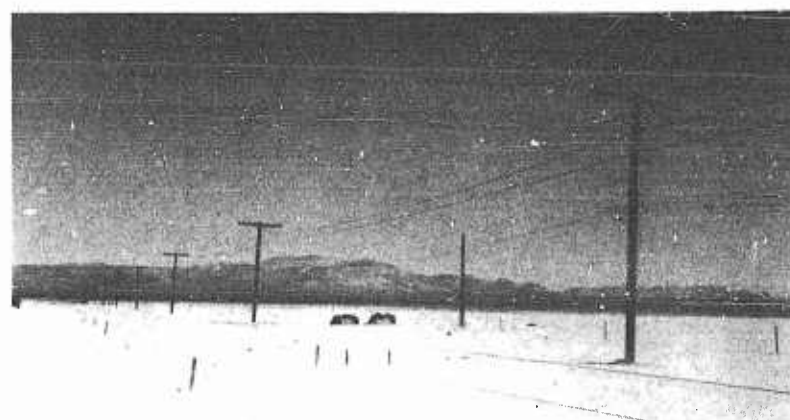
Fig. 3.10 Shots 9 and 10, Test Groups 1 and 1A, Radial Pole Line, Poles D-1 through D-23. D-23 in Foreground. (Top-before 9, Center-after 9, Bottom-after 10)
 Shot 9 - 9080-5600 ft, 8-24.5 cal, 3-5.4 psi.
 Shot 10 - 8350-4975 ft, 5.5-17.5 cal, 1-3.5 psi.

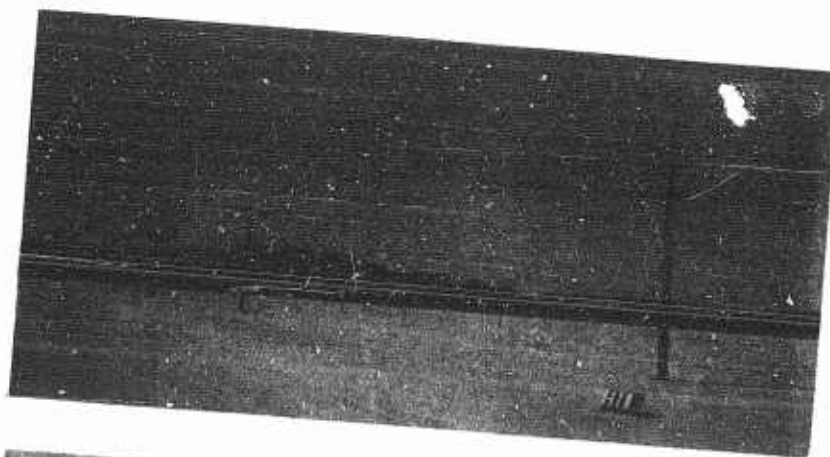
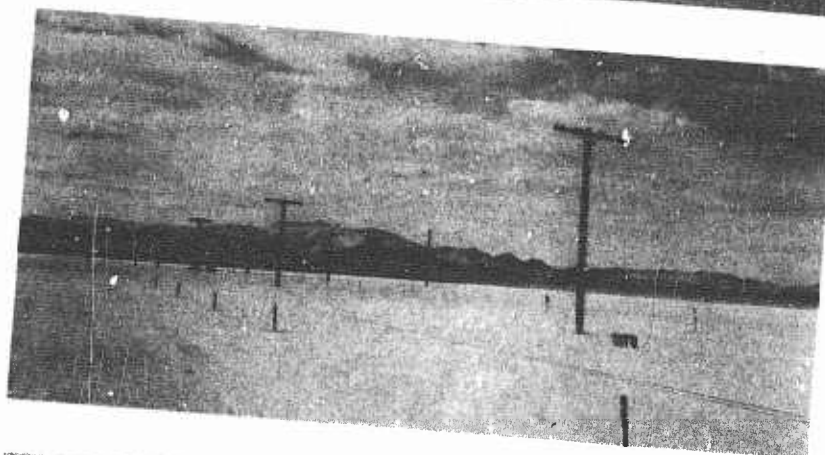
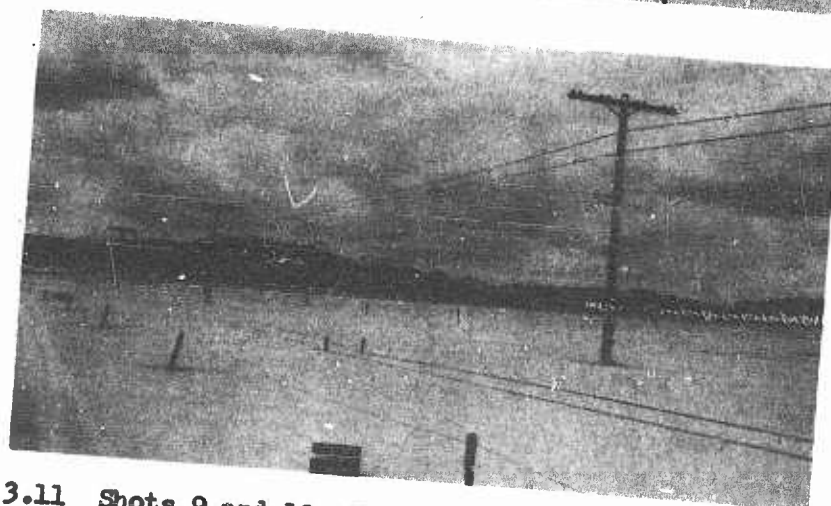
Fig. 3.11 Shots 9 and 10, Test Groups 1 and 1A, Radial Pole Line, Poles D-1 through D-26. D-26 in Foreground. (Top-before 9, Center-after 9, Bottom-after 10)
 Shot 9 - 9080-5150 ft, 8-27.5 cal, 3-5.8 psi.
 Shot 10 - 8350-4500 ft, 5.5-21 cal, 1-4 psi.

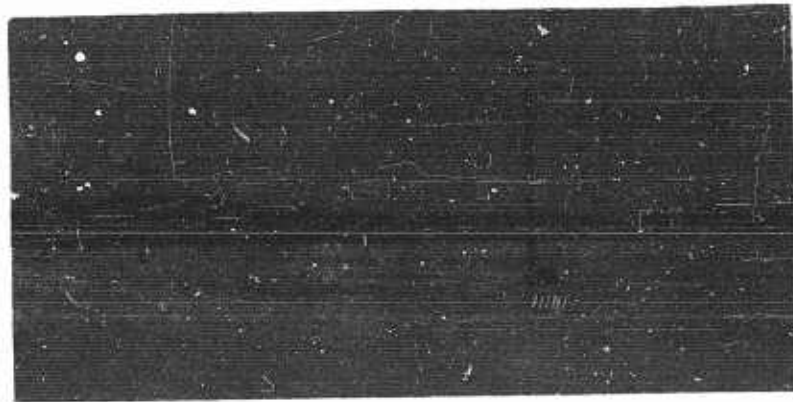
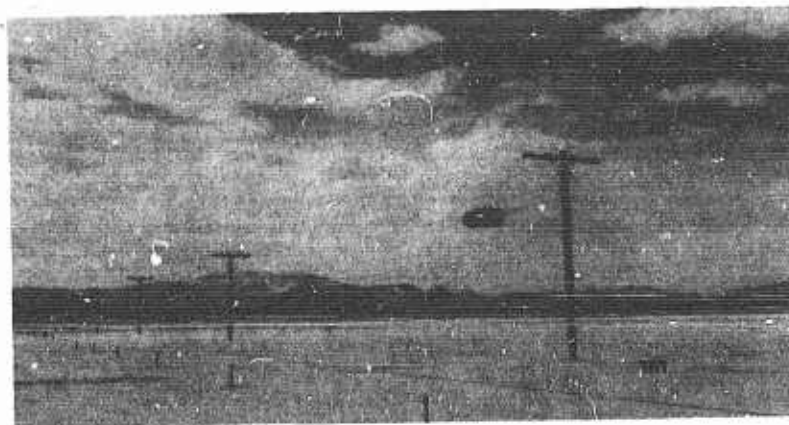
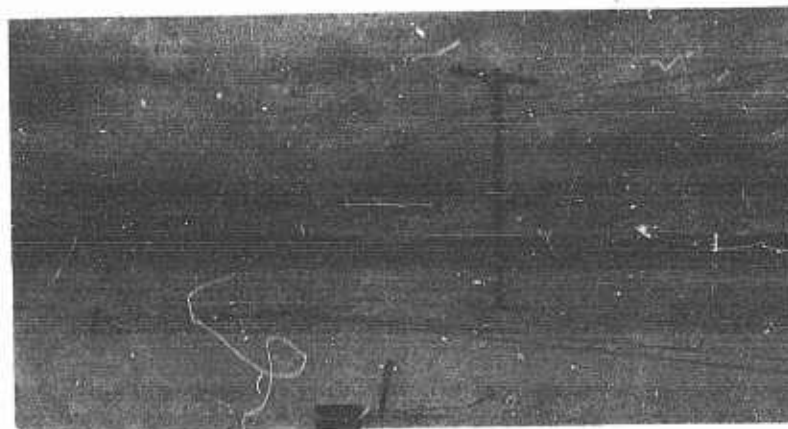
Fig. 3.12 Shots 9 and 10, Test Groups 1 and 1A, Radial Pole Line, Poles D-25 through D-28. D-28 in Foreground.
 (Top-before 9, Center-after 9, Bottom-after 10)
 Shot 9 - 5280-4750 ft, 26.5-31 cal, 5.7-6.6 psi.
 Shot 10 - 4670-4150 ft, 20.5-24.5 cal, 4-4 psi.

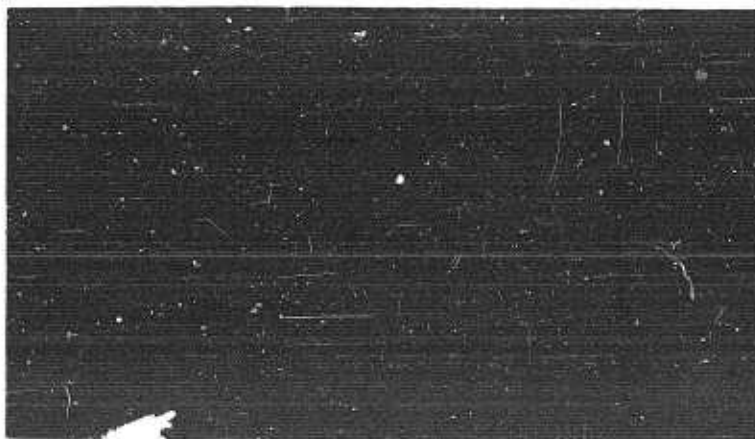
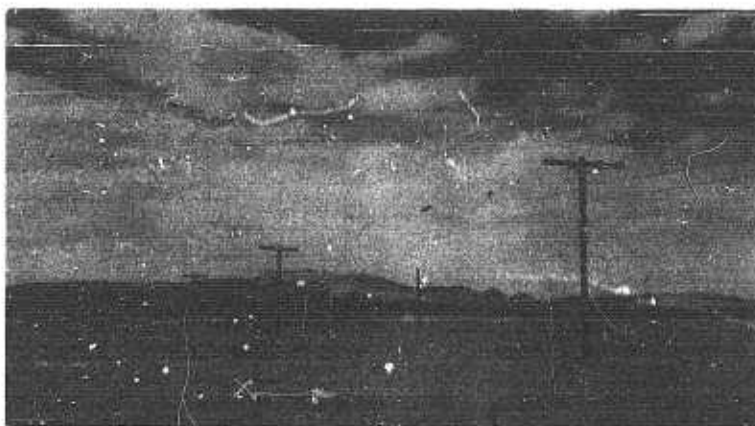
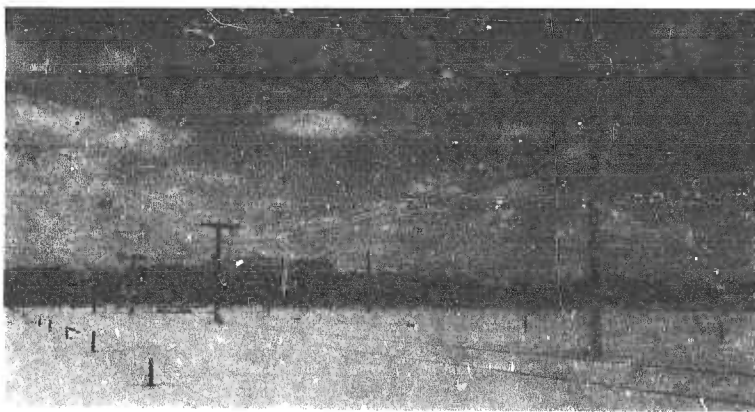
Fig. 3.13 Shots 9 and 10, Test Groups 1 and 1A, Radial Pole Line, Poles D-1 through D-31. D-31 in Foreground.
 (Top-before 9, Center-after 9, Bottom-after 10)
 Shot 9 - 9080-4380 ft, 8-35 cal, 3-7.2 psi.
 Shot 10 - 8350-3750 ft, 5.5-27 cal, 1-4 psi.

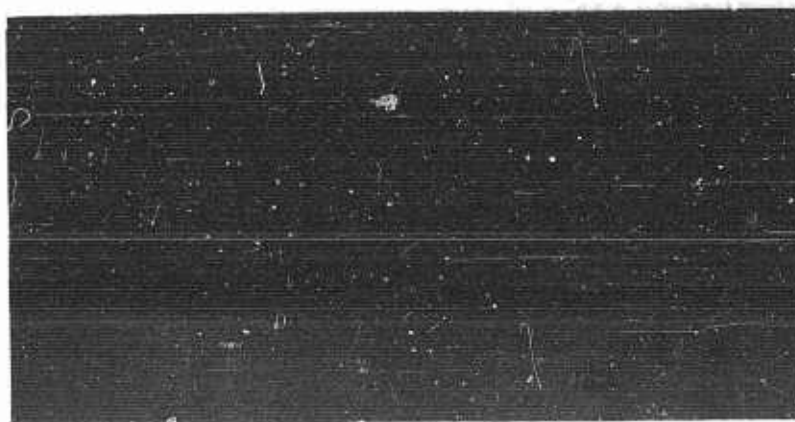
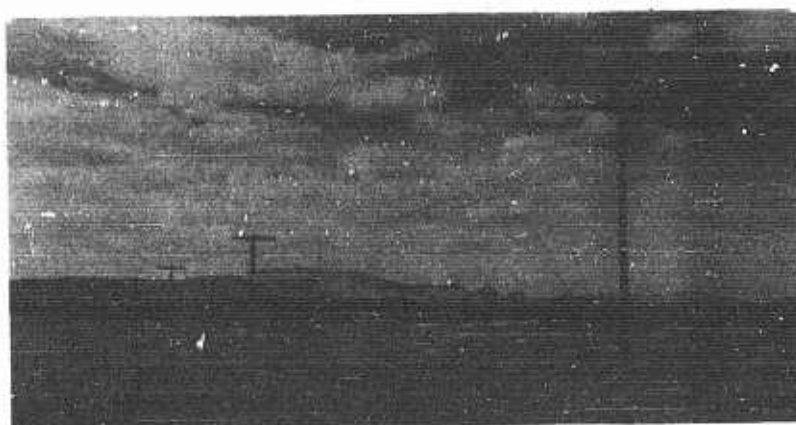
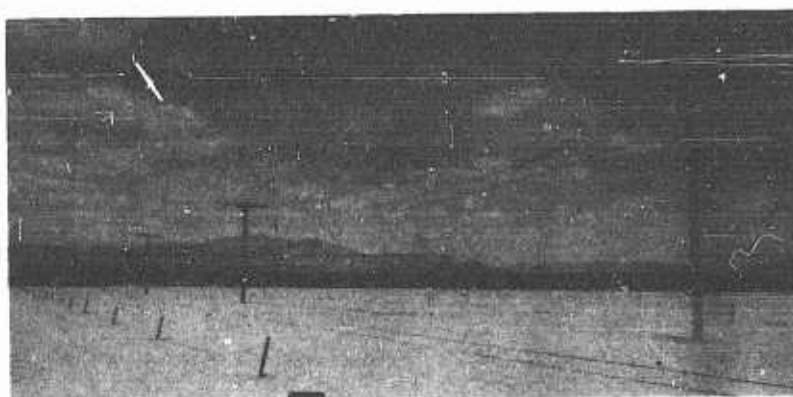
Fig. 3.14 Shots 9 and 10, Test Groups 1 and 1A, Radial Pole Line, Poles D-1 through D-34. D-34 in Foreground.
 (Top-before 9, Center-after 9, Bottom-after 10)
 Shot 9 - 9080-3900 ft, 8-42.5 cal, 3-8.4 psi.
 Shot 10 - 8350-3300 ft, 5.5-37.5 cal, 1-5 psi.

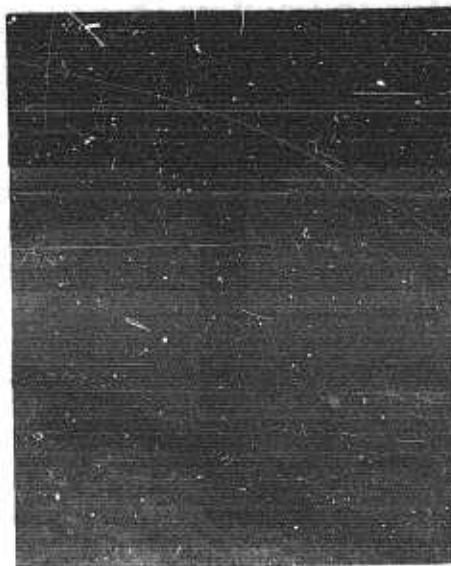
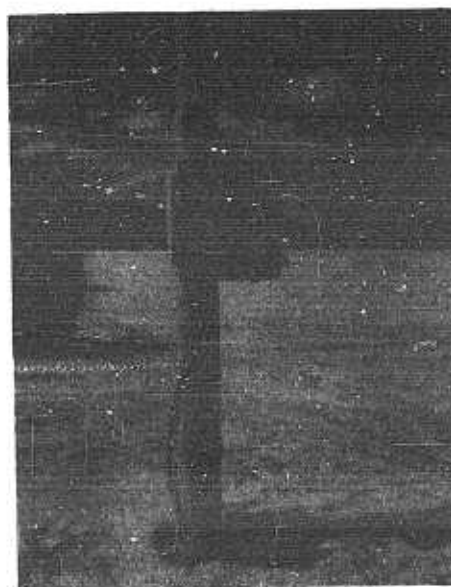
Fig. 3.15 Shot 9, Test Group 1, Radial Pole Line, Cable Transfer Relay on Pole D-35. (Top-before, Bottom-after) 3750 ft, 44.5 cal, 8.8 psi.

(11) CABLE TRANSFER RELAYS: The cable transfer relays mounted on poles D-52 (1250 ft, 113 cal, 16.6 psi) and D-42 (2750 ft, 63 cal, 10.8 psi) showed no visible damage other than that the lead sheath on the riser cables was melted away for lengths of several inches on the GZ side exposing the paper covered conductors. Laboratory analysis of these relays reveals that these two relays were sound structurally and undamaged mechanically. There was no evidence of thermal damage to the relays, housing, mounting details or damage to the internal wires or insulation. These units were found to be in an immediate reusable state. Service would not have been interrupted through the relay contact except, perhaps, for a relay contact bounce during the momentous impact upon hitting the ground if the poles on which the units were mounted were destroyed. The breaks in the cable sheaths might result in moisture damage later on if not repaired. (One cable transfer relay was installed in a manhole, (Test Group 96) and

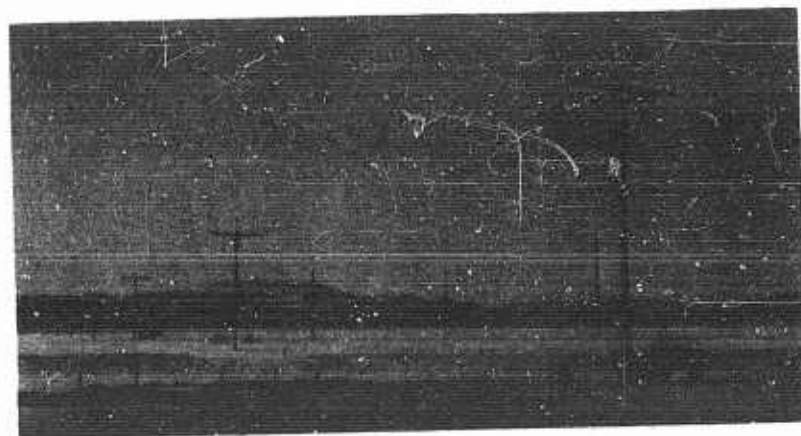
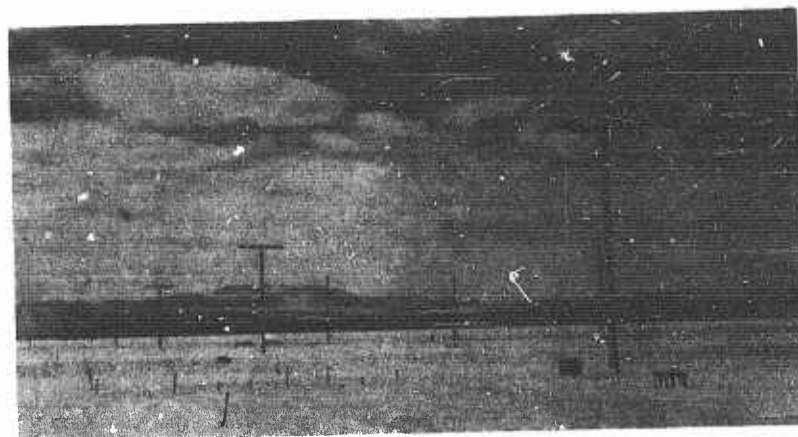
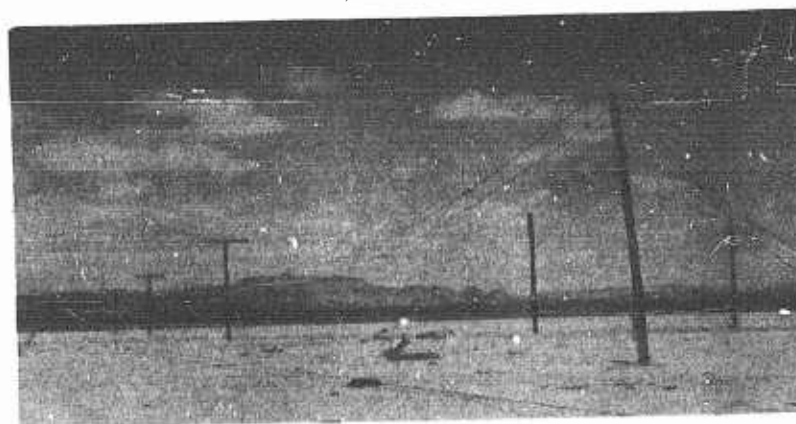
Fig. 3.16 Shots 9 and 10, Test Groups 1 and 1A, Radial Pole Line
 (Top-before 9, Poles D-1 through D-37; Center-after 9, Poles
 D-1 through 37; Bottom-after 10, Poles D-1 through D-36)
 (D-37 through D-52 Not Shown in this Photo were Destroyed in
 Shot 10) Shot 9 - 9080-3500 ft, 8-49 cal, 3-9.4 psi.
 Shot 10 - 8350-2900 ft, 5.5-47.5 cal, 1-5 psi.

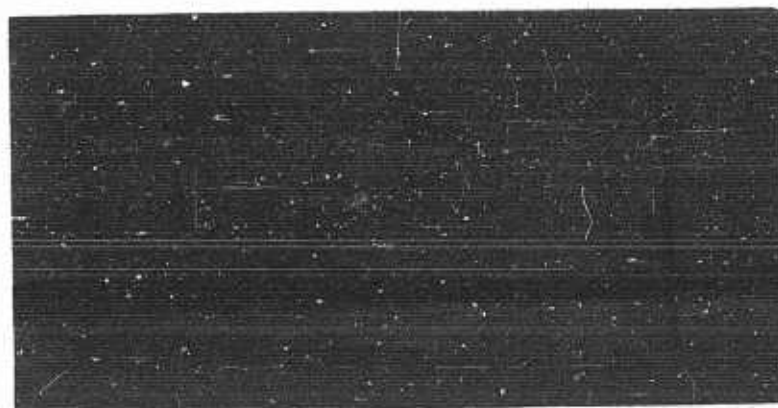
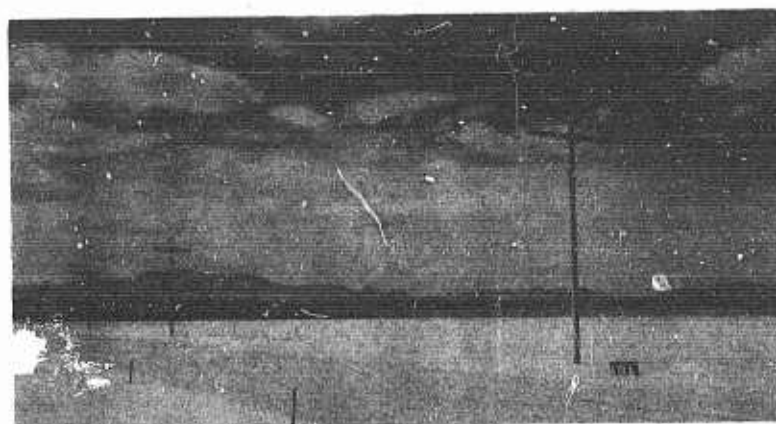
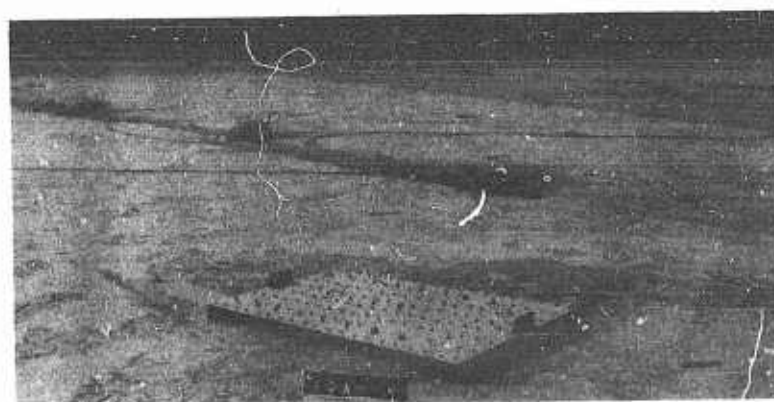
Fig. 3.17 Shots 9 and 10, Test Groups 1 and 1A, Radial Pole Line, Poles D-1 through 40, Top and Center Views. D-40 in Foreground; D-1 through D-40 in Bottom View; D-36 in Background. Poles D-37 through D-52 were Destroyed in Shot 10. (Top-before 9, Center-after 9, Bottom-after 10) Shot 9 - 9080-3050 ft, 8-57.5 cal, 3-10.4 psi. Shot 10 - 8350-2425 ft, 8- over 65 cal, 1-6 psi.

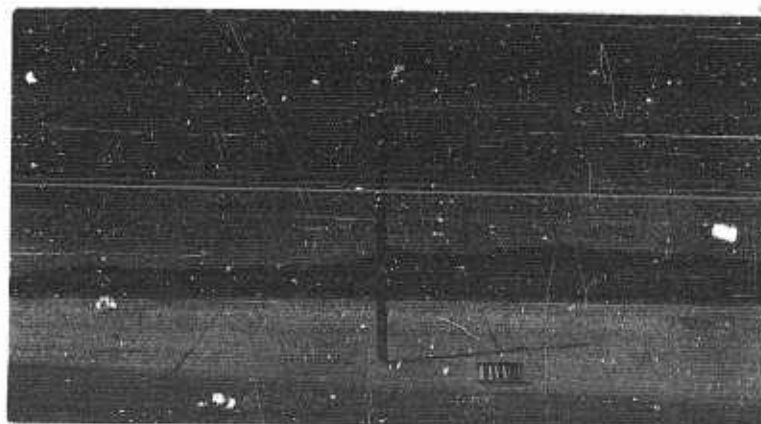
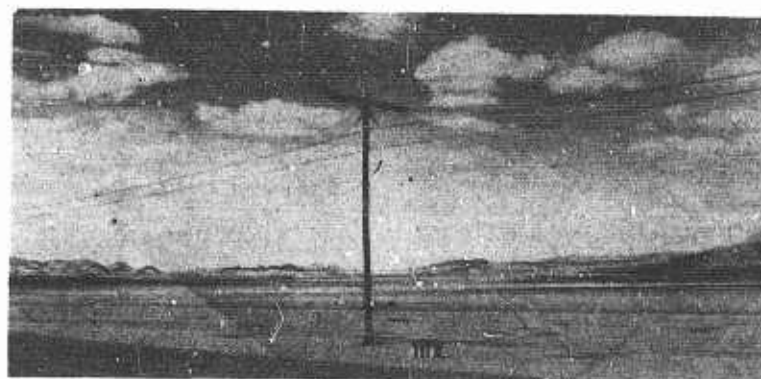
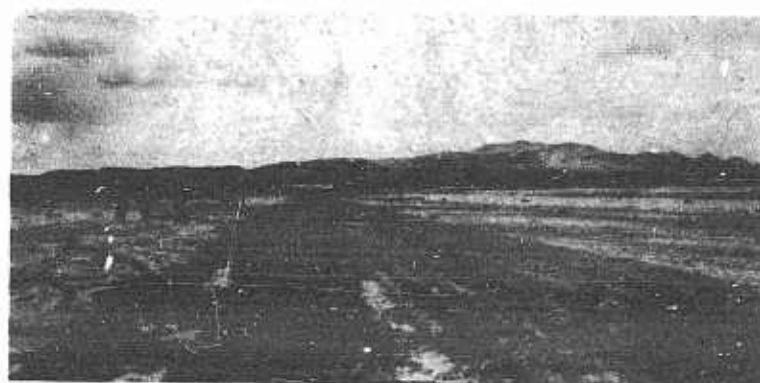
Fig. 3.18 Shots 9 and 10, Test Groups 1 and 1A, Radial Pole Line, Pole D-41. In Bottom View Poles D-37 through D-52 Destroyed in Shot 10. (Top-before 9, Center-after 9, Bottom-after 10)
 Shot 9 - 2900 ft, 60 cal, 10.6 psi.
 Shot 10 - 2250 ft, 65 cal, 7 psi.

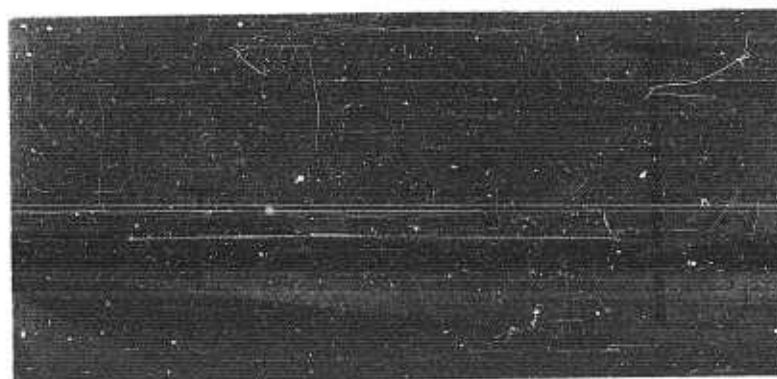
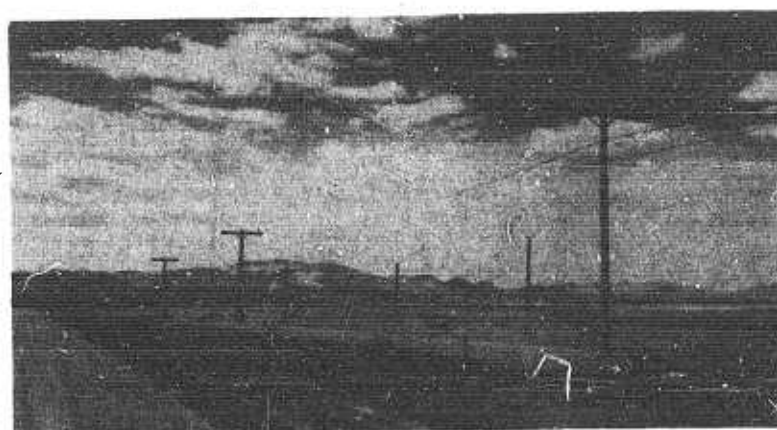
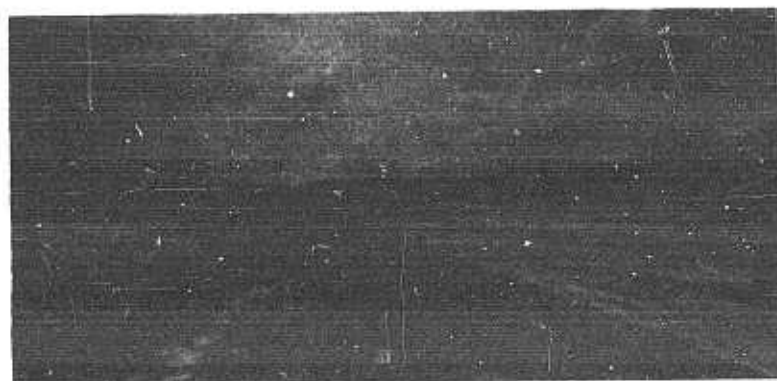
Fig. 3.19 Shots 9 and 10, Test Groups 1 and 1A, Radial Pole Line, Poles D-1 through D-44. D-44 in Foreground in Top and Center Views. In Bottom View Poles D-37 through D-52 have been destroyed in Shot 10. (Top-before 9, Center-after 9, Bottom-after 10)
 Shot 9 - 9080-2450 ft, 8-69 cal, 3-11.2 psi.
 Shot 10 - 8350-1820 ft, 5- over 65 cal, 1-9 psi.

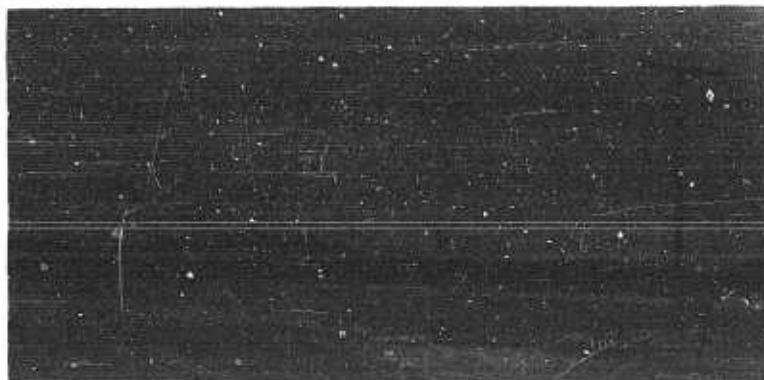
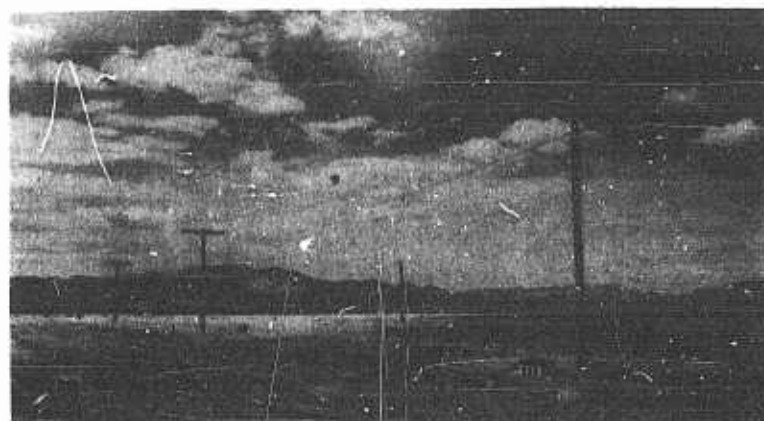
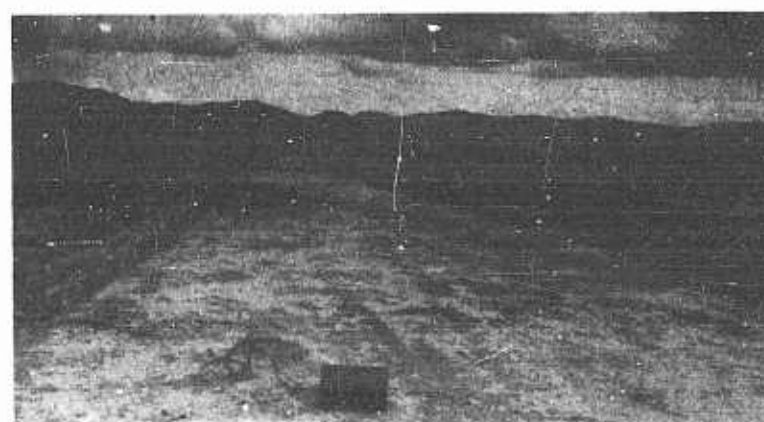
Fig. 3.20 Shots 9 and 10, Test Groups 1 and 1A, Radial Pole Line, Poles D-1 through D-47. D-47 in Foreground in Top and Center Views. In Bottom View Poles D-37 through D-52 have been Destroyed, D-41 Position in Foreground. (Top-before 9, Center-after 9, Bottom-after 10) Shot 9 - 9080-2000 ft, 8-82 cal, 3-12.6 psi. Shot 10 - 8350-1350 ft, 5.5-over 65 cal, 1-20 psi.

(7) 26 PAIR LEAD COVERED CABLE: The only damage to the 26 pair lead covered cable occurred at the last six poles closest to GZ (poles D-52 through D-47; 1250-2000 ft, 113-82 cal, 16.6-12.6 psi). In this section the lead sheath ruptured and separated adjacent to the messenger suspension clamp exposing the paper covered conductors all the way around the cable for a distance of 1/2 to 1 in. Twenty-five of the 26 pairs in the cable were operable after the shot. Wet weather would render this damaged cable inoperative should immediate repairs not be made.

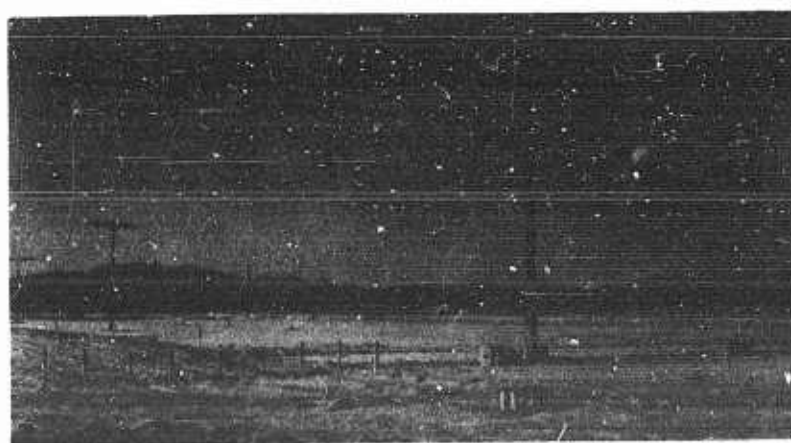
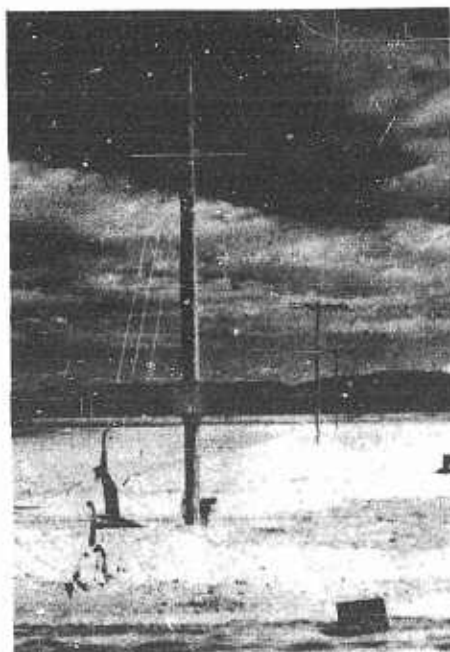
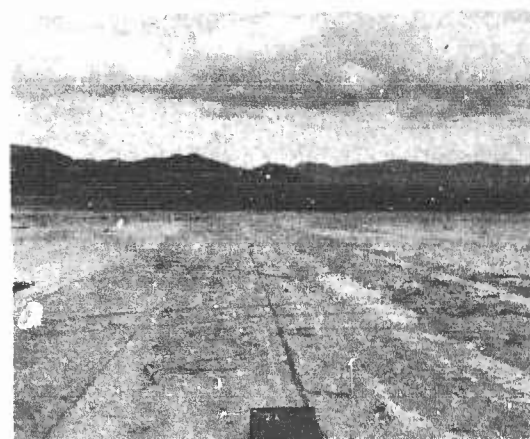
Fig. 3.22 Shots 9 and 10, Test Groups 1 and 1A, Radial Pole Line, Poles D-52 through D-50 in Top View, D-52 in Foreground; Poles D-52 through D-1 in Bottom Left View, D-52 in Foreground; Poles D-52 through D-36 Bottom Right View Destroyed in Shot 10. (Top-before 9, Bottom Left-after 9, Bottom Right-after 10)
 Shot 9 - 1550-1250 ft, 98-113 cal, 14.16.6 psi.
 Shot 10 - 2250-600 ft, over 65 cal, 7.0-over 115 psi.

(2) CROSSARMS: All crossarms received slight surface charring on the GZ faces but damage was negligible. The outside crossarm of double crossarm on the dead end pole closest to GZ (pole D-52 at 1250 ft; 113 cal, 16.6 psi) was slightly twisted. All crossarms were serviceable after the shot.

(4) GLASS INSULATORS: All insulators on the outside crossarms on the dead end pole (pole D-52 at 1250 ft; 113 cal, 16.6 psi) were broken. There were two broken insulators on pole D-51 at 1400 ft; 103 cal, 15.4 psi. In all cases where there were broken insulators the open wire remained attached to the insulator and pin. All other insulators were serviceable after the shot.

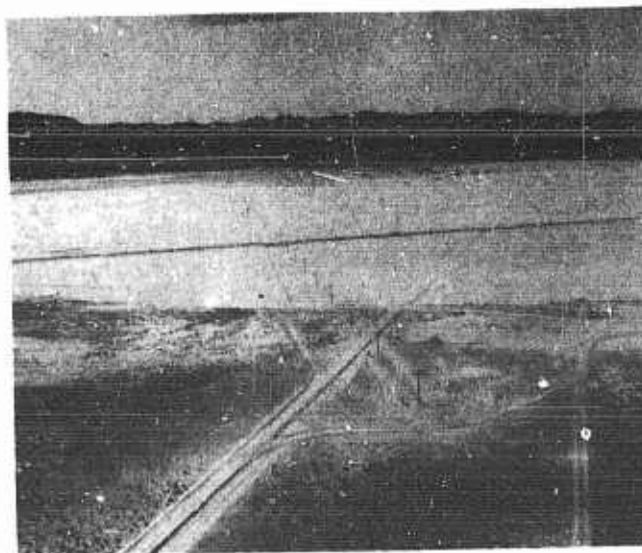
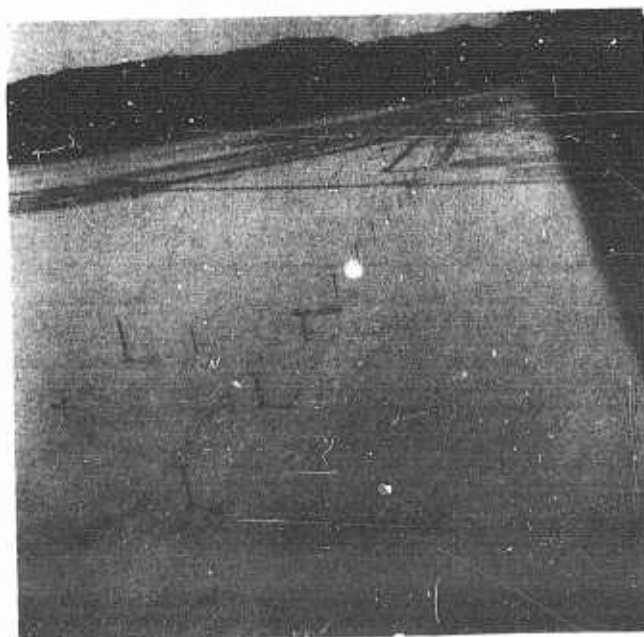
Fig. 3.23 Shot 10, Miscellaneous Aerial Views, Test Group 1A, Radial Pole Line. All Views after Shot 10. (Top-entire Pole Line from Poles D-1 through D-52, D-1 in Foreground; Bottom-poles D-27 through D-37; Note All Poles Down, D-36 through D-52.

b. RESULTS: The pole line as a whole received severe damage from pole D-52 (600 ft, over 65 cal, over 115 psi), out to and including pole D-37 (2900 ft, 47.5 cal, 5.0 psi). In this section of the line 16

poles were splintered at the base of the poles, broken or disintegrated into one or more pieces and blown about the area along the pole line. There was a miscellaneous conglomeration of crossarms, pins, insulators, open wire, lead covered cable, rubber covered cable, spiral four cable, and field wire snarled together along this section of the pole line. The degree of severe damage stopped abruptly at pole D-36. Damage summaries are shown in Table 3.4.
